SEALED LITHIUM INORGANIC ELECTROLYTE CELL

GTE Laboratories, Incorporated

ECOM - 74-0108-7

Quarterly Report for Period 1 September to 31 December 1975

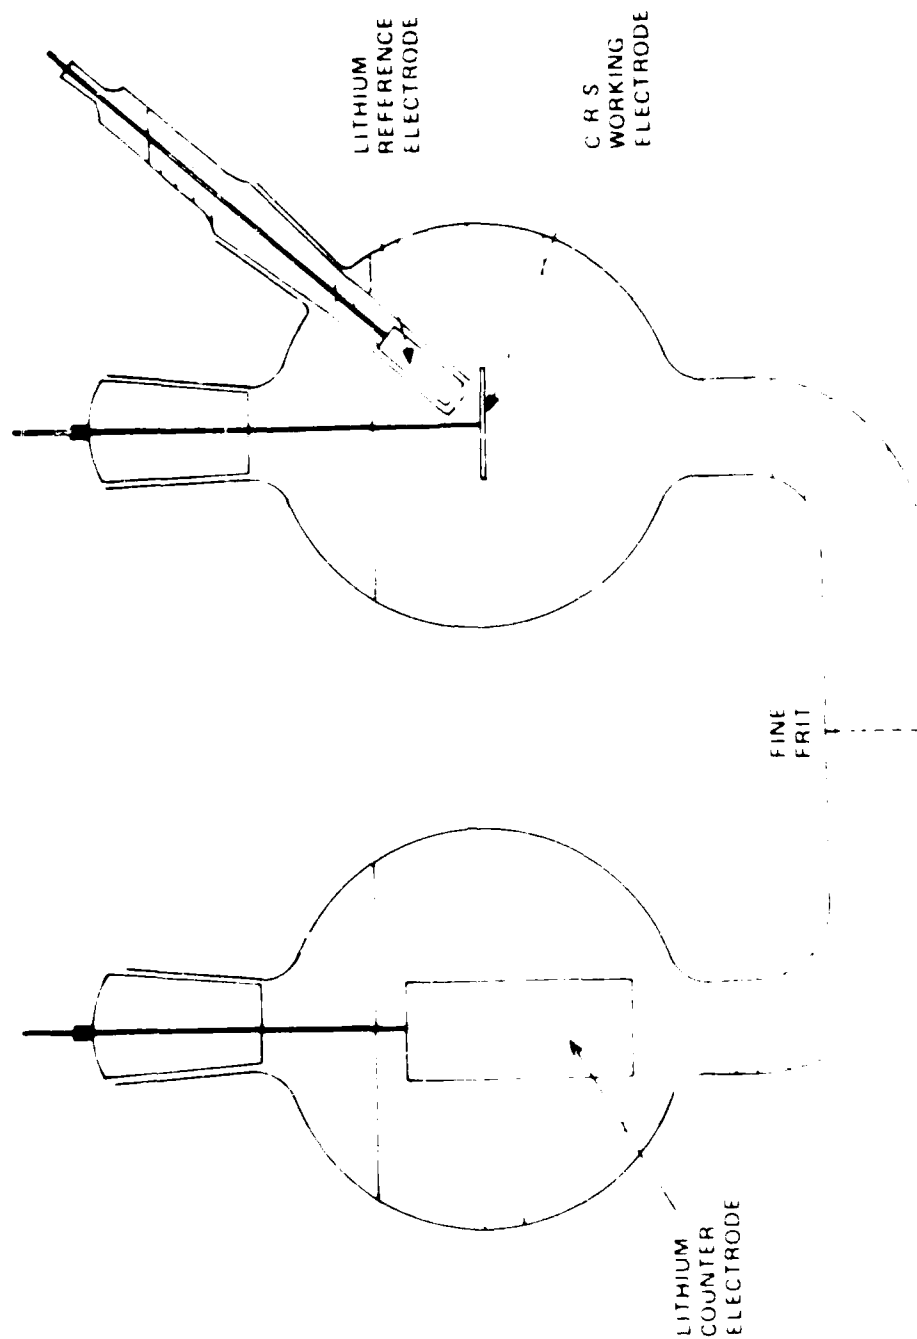
Figure 1. Glass Cell Arrangement for Corrosion Studies

A glass cell was constructed as shown in Figure 1. A fine frit divided the two chambers. A second joint was built into one of the chambers to accommodate a lithium reference electrode. The tube holding the reference electrode was separated from the bulk of the solution by a fine frit and a slight positive pressure was maintained by overfilling the reference tube. The entire cell was immersed in an oil bath at 72°C and brought to equilibrium. The working electrode was a round disk of cold rolled steel 11.28 cm<sup>2</sup> (one side). The Li reference electrode was placed directly above the back side of the working electrode in very close proximity. Each chamber contained 200 cm<sup>3</sup> of electrolyte. The working electrode was kept at the potential of the lithium reference electrode, while the current was monitored between the working and the lithium counter electrode.

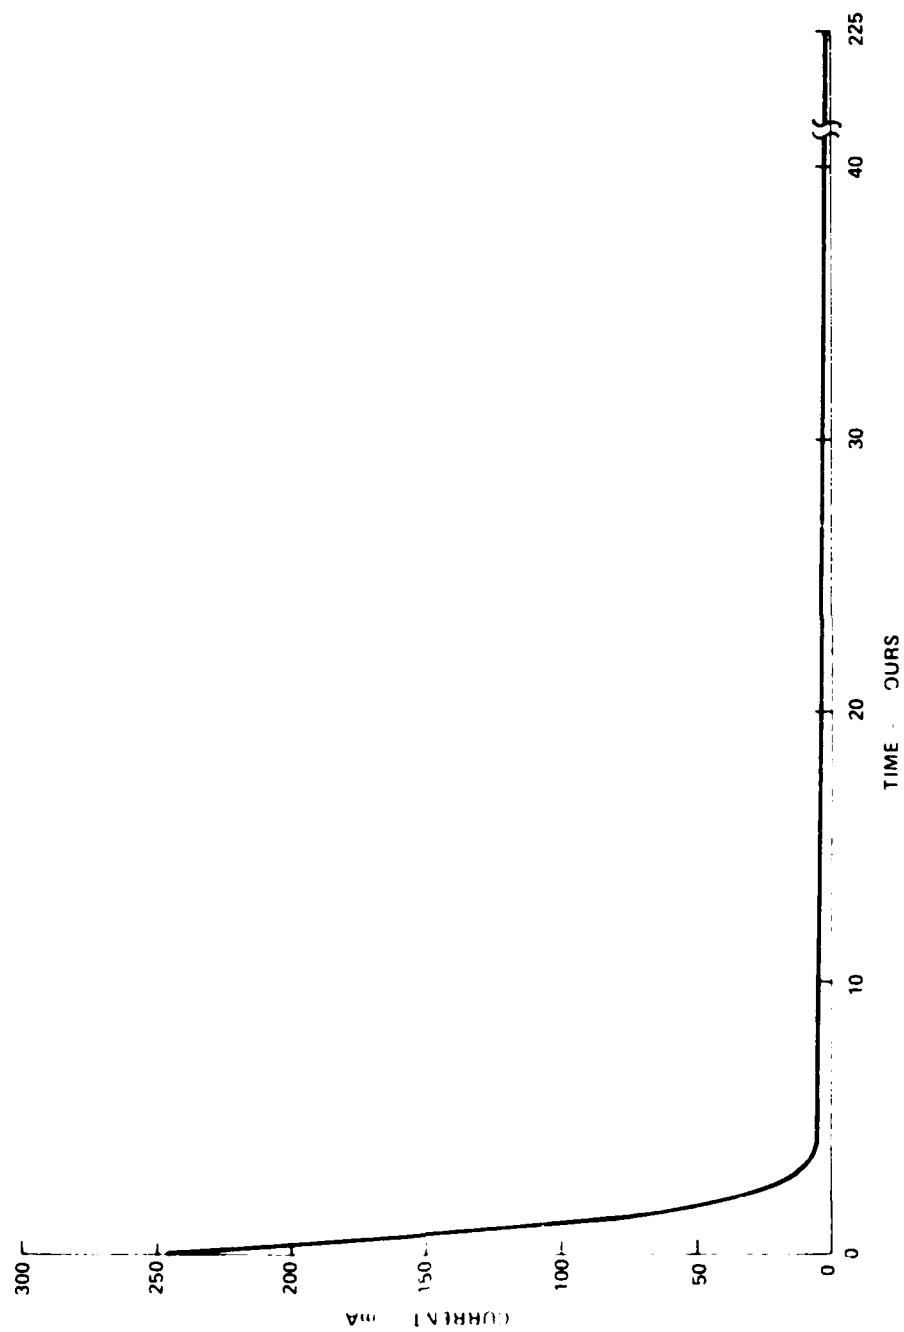
Figure 2. Self Discharge on Cold Rolled Steel

Upon initiation of the test, there was a strong cathodic current indicating the reduction of thionyl chloride on the surface of the working electrode (cold rolled steel). The current was 260 mA, or 23 mA/cm<sup>2</sup> of electrode area. As shown in Figure 2, the current decayed in a few hours to 6 mA, after 25 hours to 4 mA and leveled off at

1.3 mA at 45 hours and remained there until completion of the experiment. This decay is attributed to the forming of a passivating film of reduction products deposited on the surface of the working electrode.

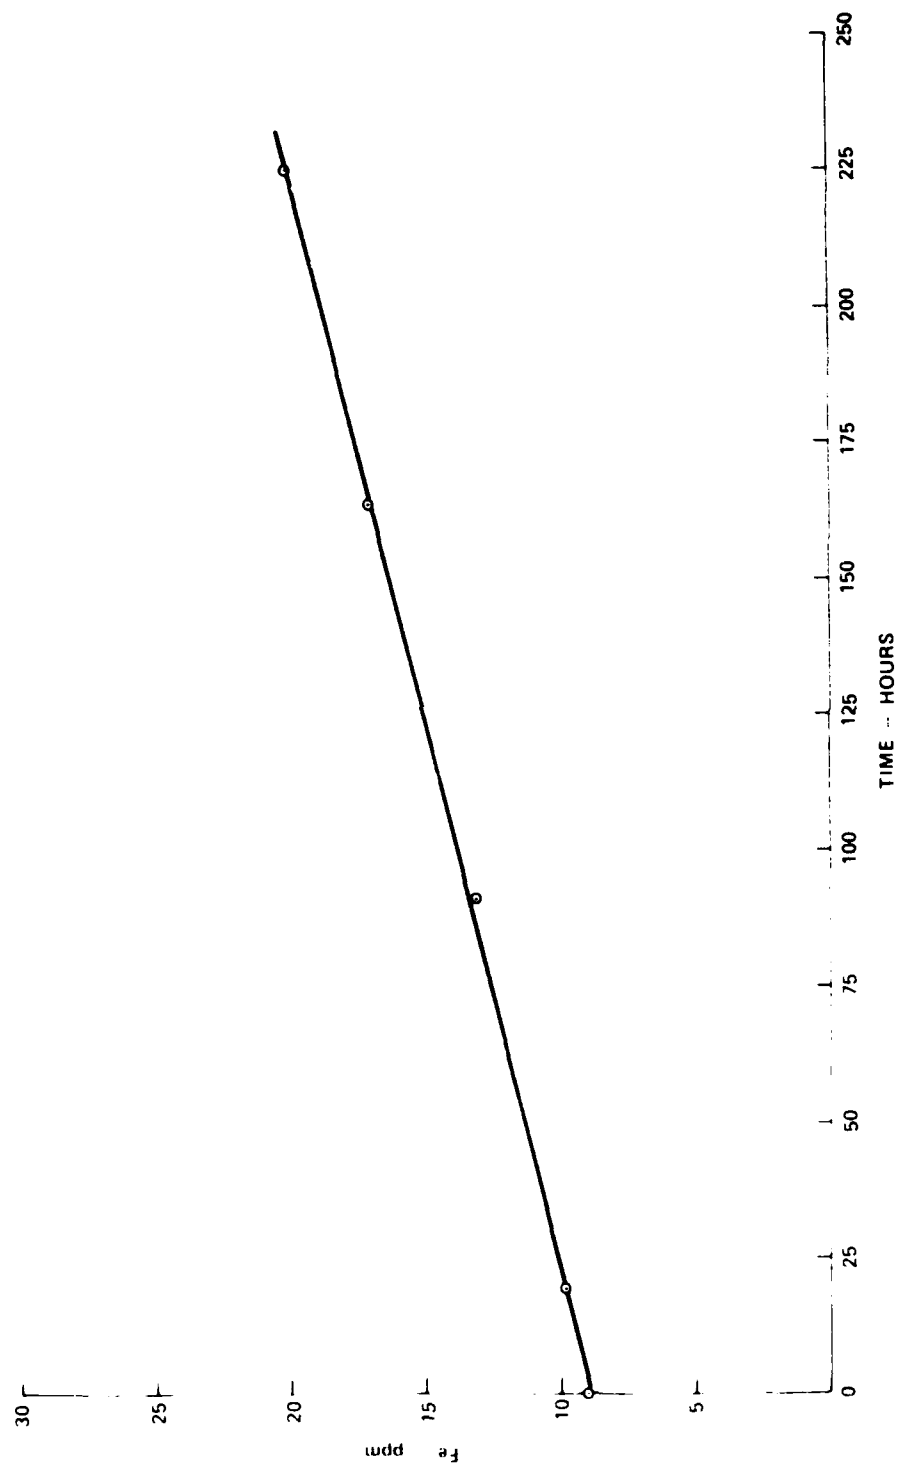
Figure 3. Iron Corrosion at Lithium Potential

The results are also represented graphically in Figure 3, showing a linear dependence on time.

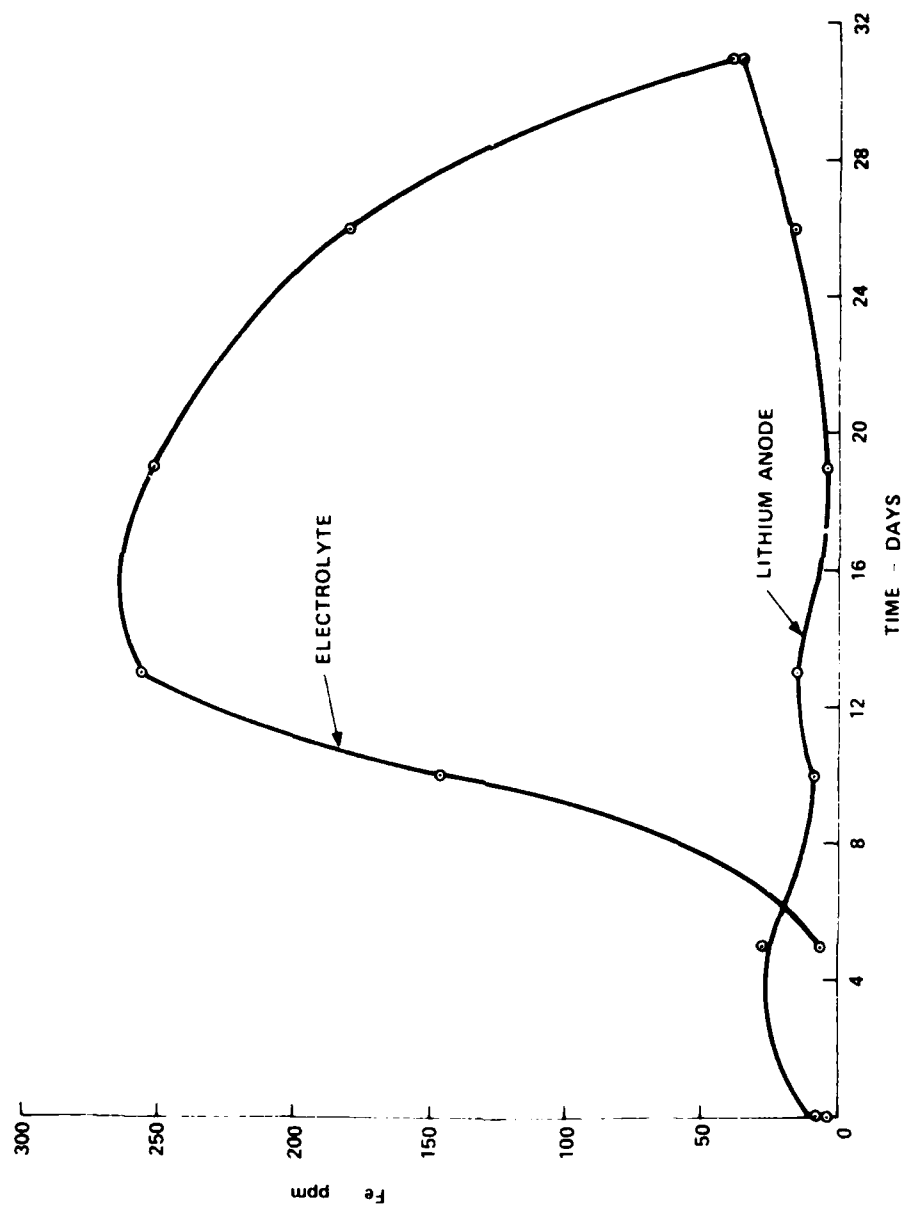
Figure 4. Distribution of Iron Generated by Corrosion in Standard Size D Cells

Figure 4 graphically depicts the data from Table 2. The graph correlates to the theory as previously explained. There is a gradual rise in Fe concentration, a

leveling out and then a slow decline, all as predicted. The confusion arises when the lithium is analyzed as described in Section 3.1. There is not a significant rise in the Fe concentration on lithium. A blank of lithium will yield an iron concentration of approximately 5 to 10 ppm. As the electrolyte iron concentration was decreasing it was assumed lithium was picking it up, but the lithium analysis did not prove that. One possible explanation may be in the washing technique. After the electrolyte was taken out of the can, it was gently sprayed with THF to wash out any extraneous electrolyte, since it would, in contact with water, attack the can and form more iron in the solution. The iron which plates out on lithium may not be adhering very well and the spraying with THF may be washing it off. This possibility is now being investigated and will be discussed in the next report.

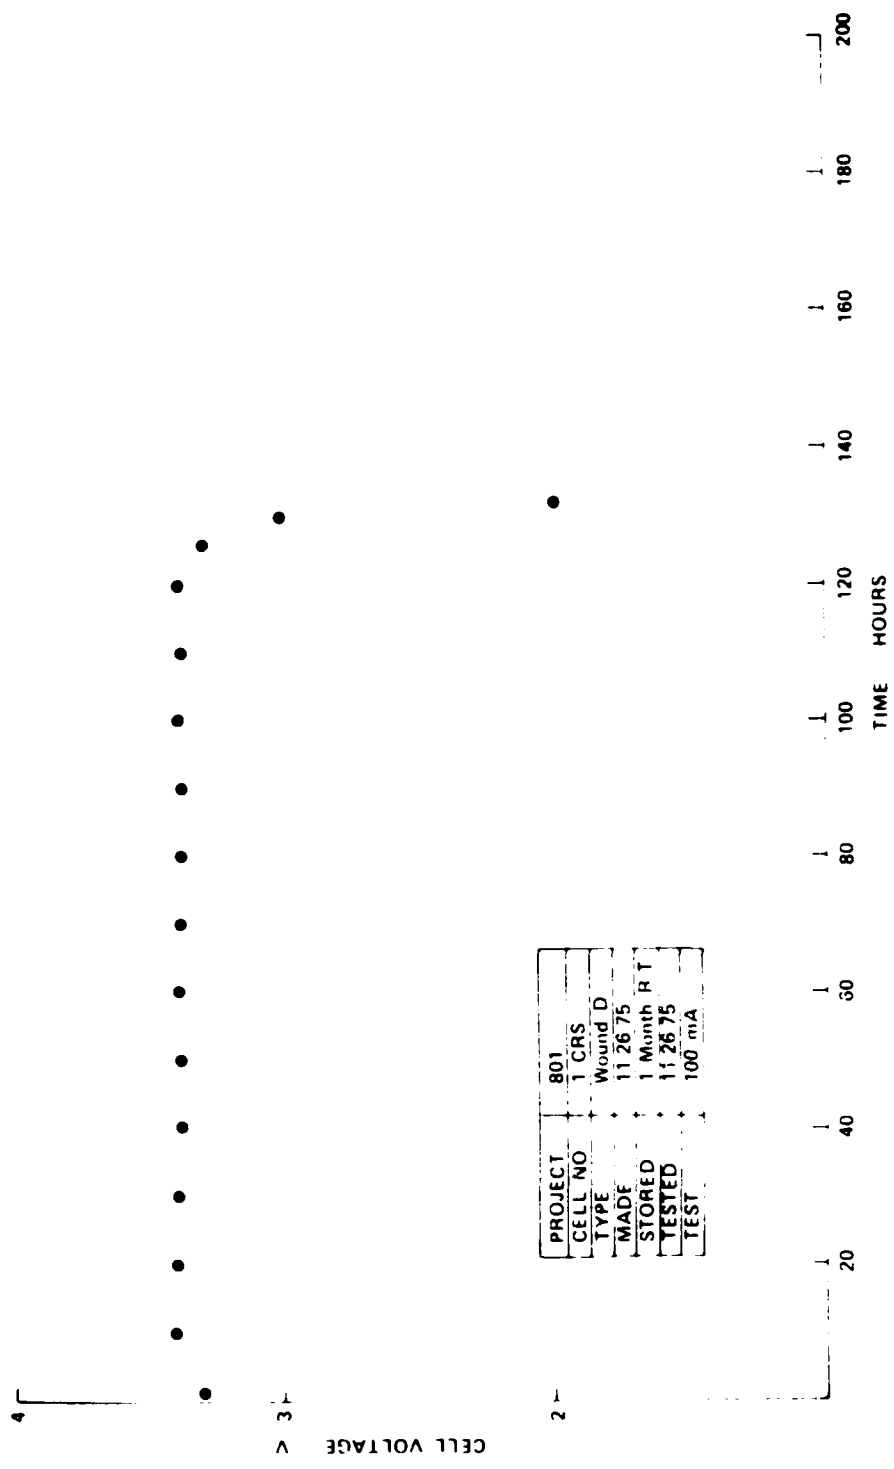
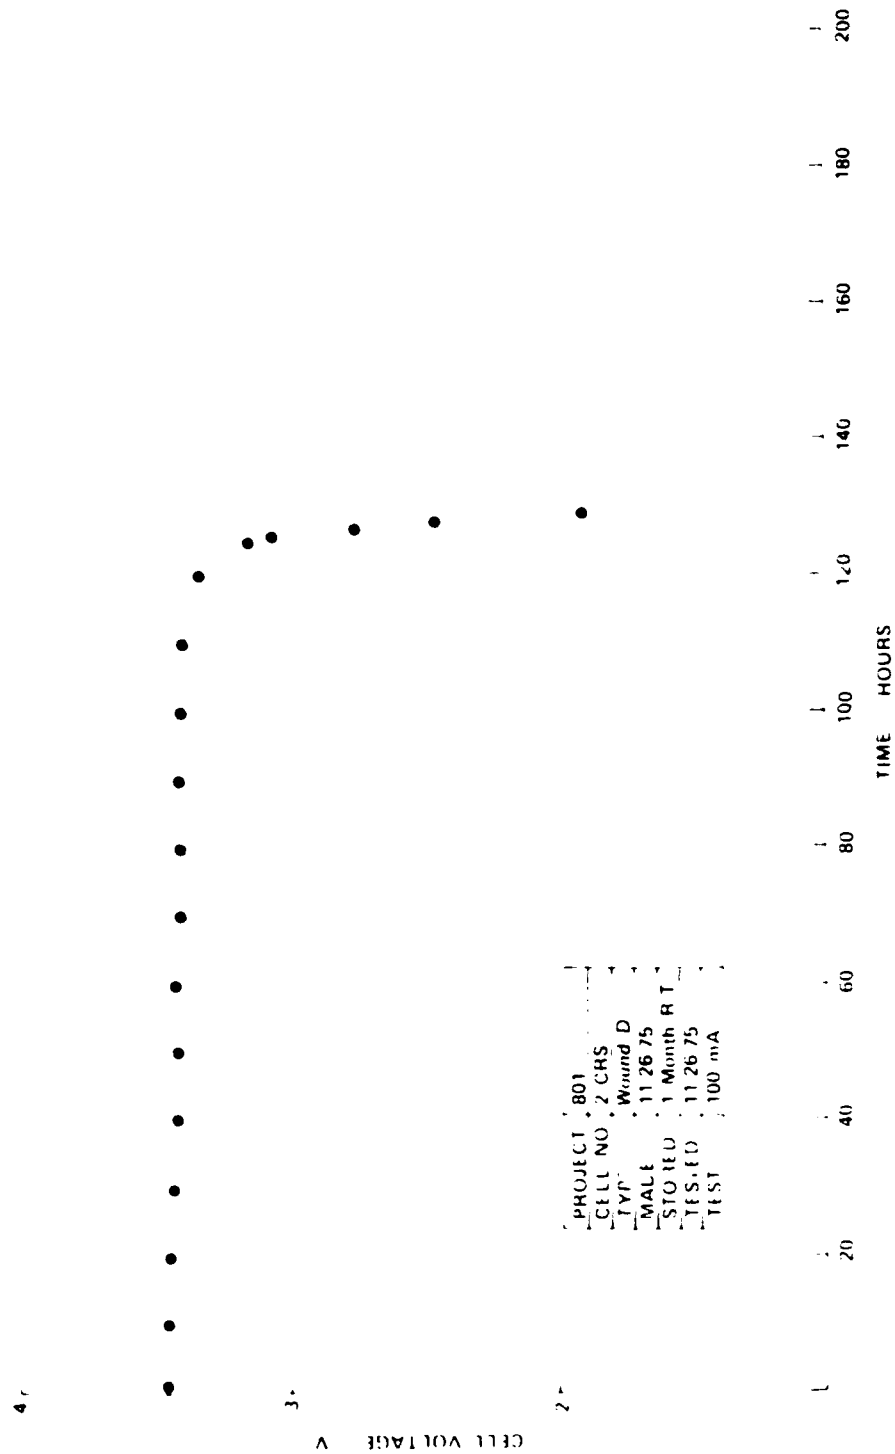
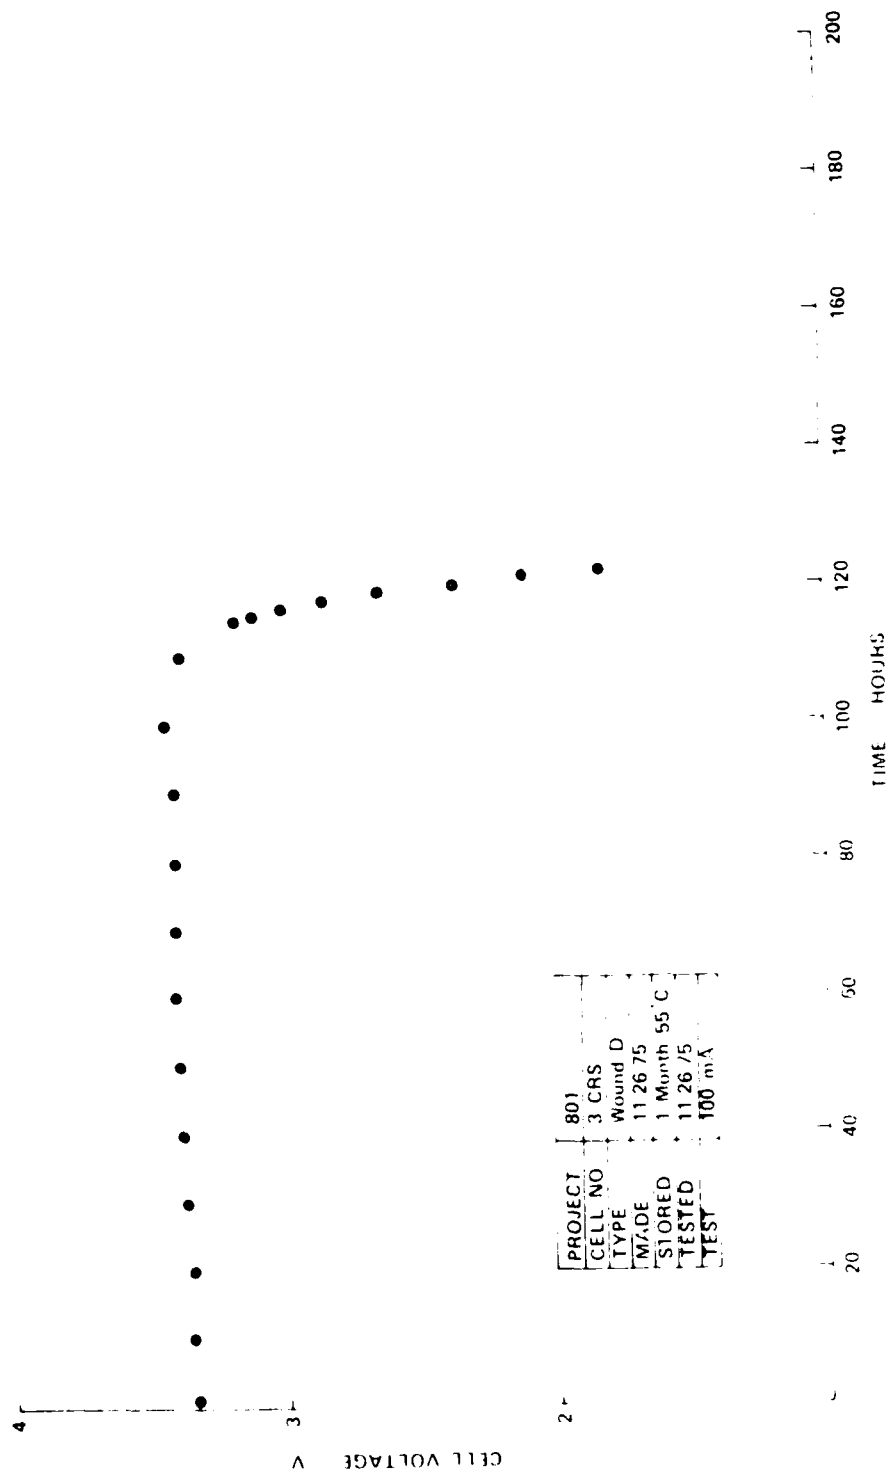
Figure 5. Discharge Curves for Standard Size D Cells after 1 Month Storage at Various Temperatures

Figure 6. Discharge Curves for Standard Size D Cells after 1 Month Storage at Various Temperatures

Figure 7. Discharge Curves for Standard Size D Cells after 1 Month Storage at Various Temperatures

As previously mentioned, six cold rolled steel cans were stored, two each at the three different temperatures, along with six stainless steel cans. After one month they were taken out of storage and allowed to equilibrate at room temperature for one half day. The delays were measured using a current of 340 mA or approximately 1 mA/cm<sup>2</sup> (both sides of cathode). Delays were measured using a Varian Aerograph Model A-5 high speed strip chart recorder and are listed in Table 3. As in previous reports, the delay is defined as any time the voltage of the cell stays below 2.0 volts during the initial phase of discharge. After the delay tests the cells were completely discharged at a constant current of 100 mA to a 2.0 volt cut-off. The capacities obtained are listed in Table 4. The actual discharge curves are shown in Figures 5 through 7.

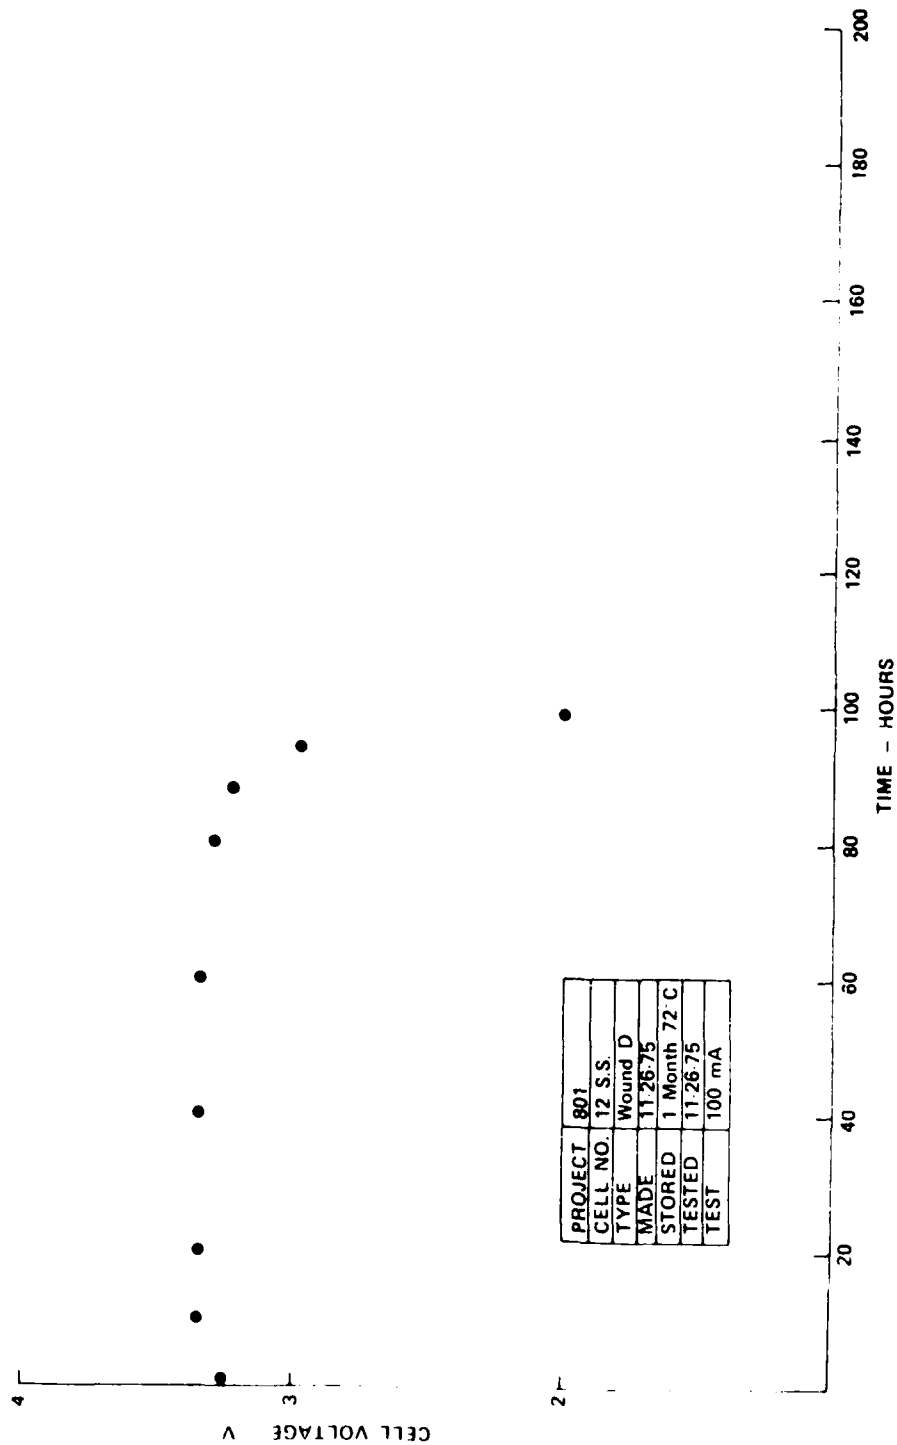
PROJECT	801
CELL NO.	12 S.S.
TYPE	Wound D
MADE	11-26-75
STORED	1 Month 72° C
TESTED	11-26-75
TEST	100 mA

Figure 14. Discharge Curves for Standard Size D Cells after 1 Month Storage at Various Temperatures

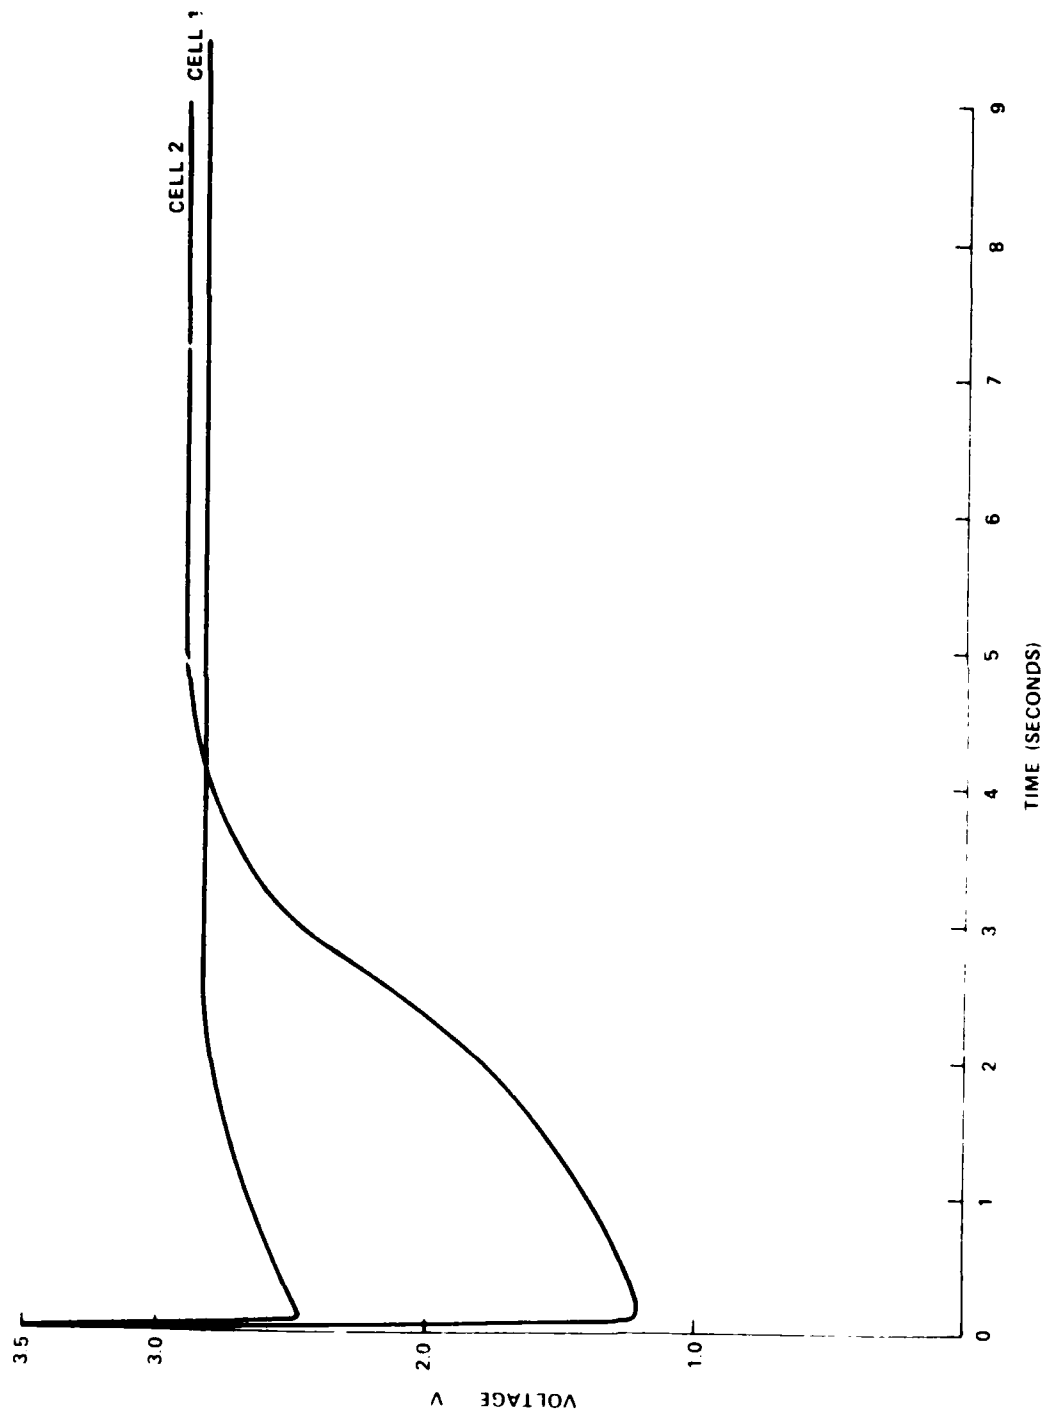
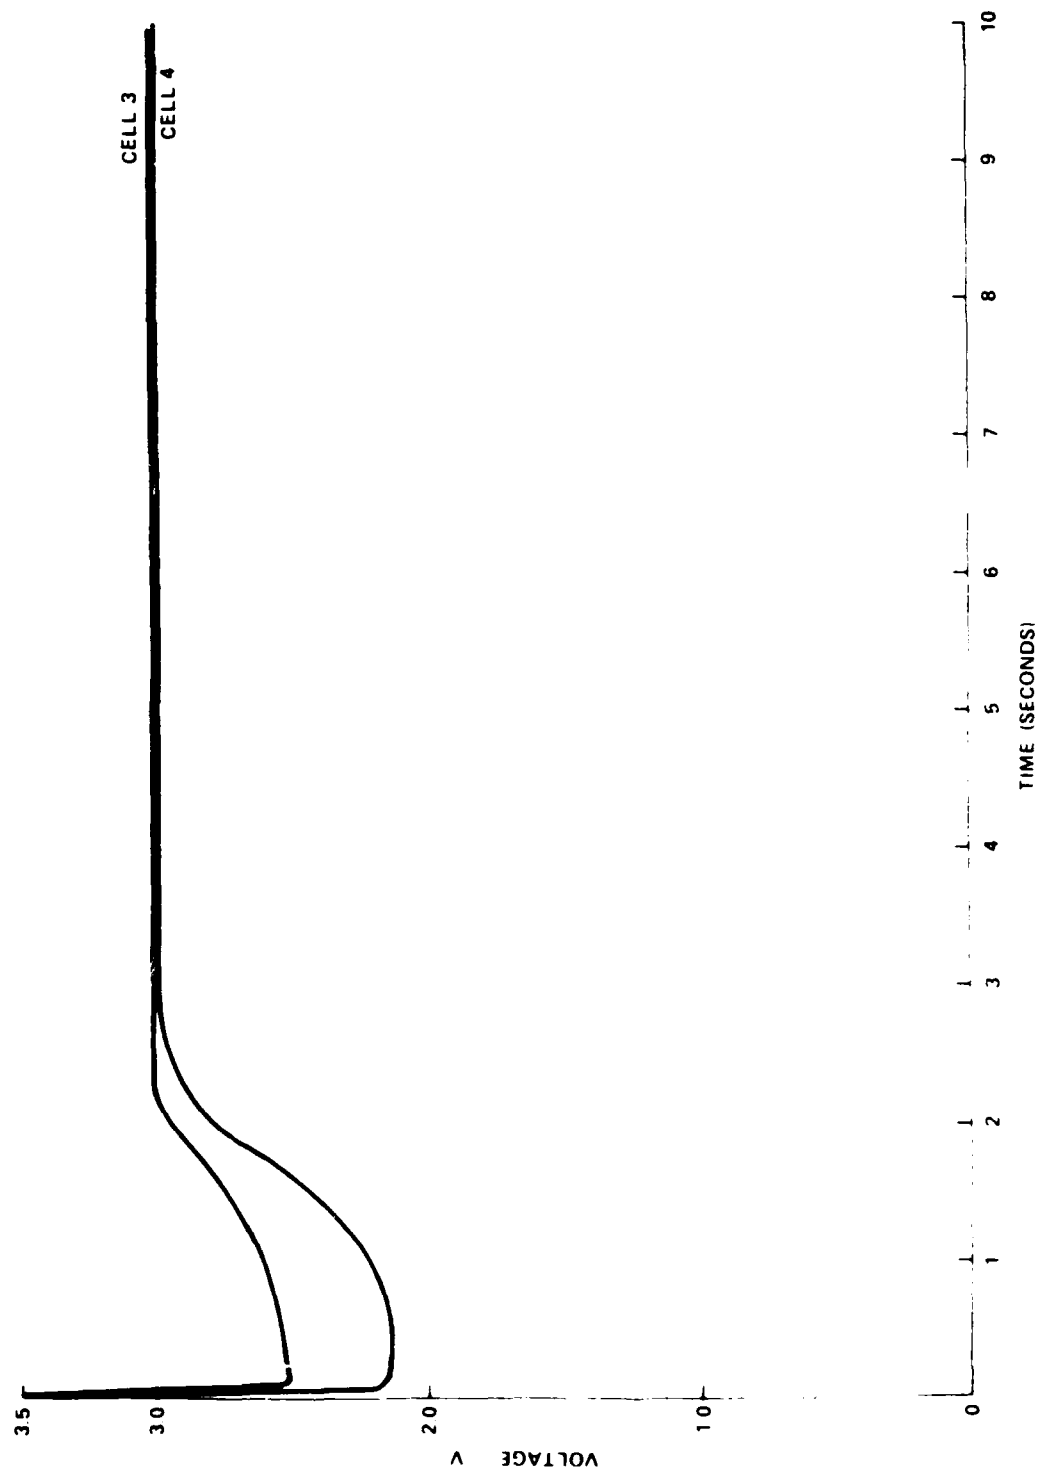
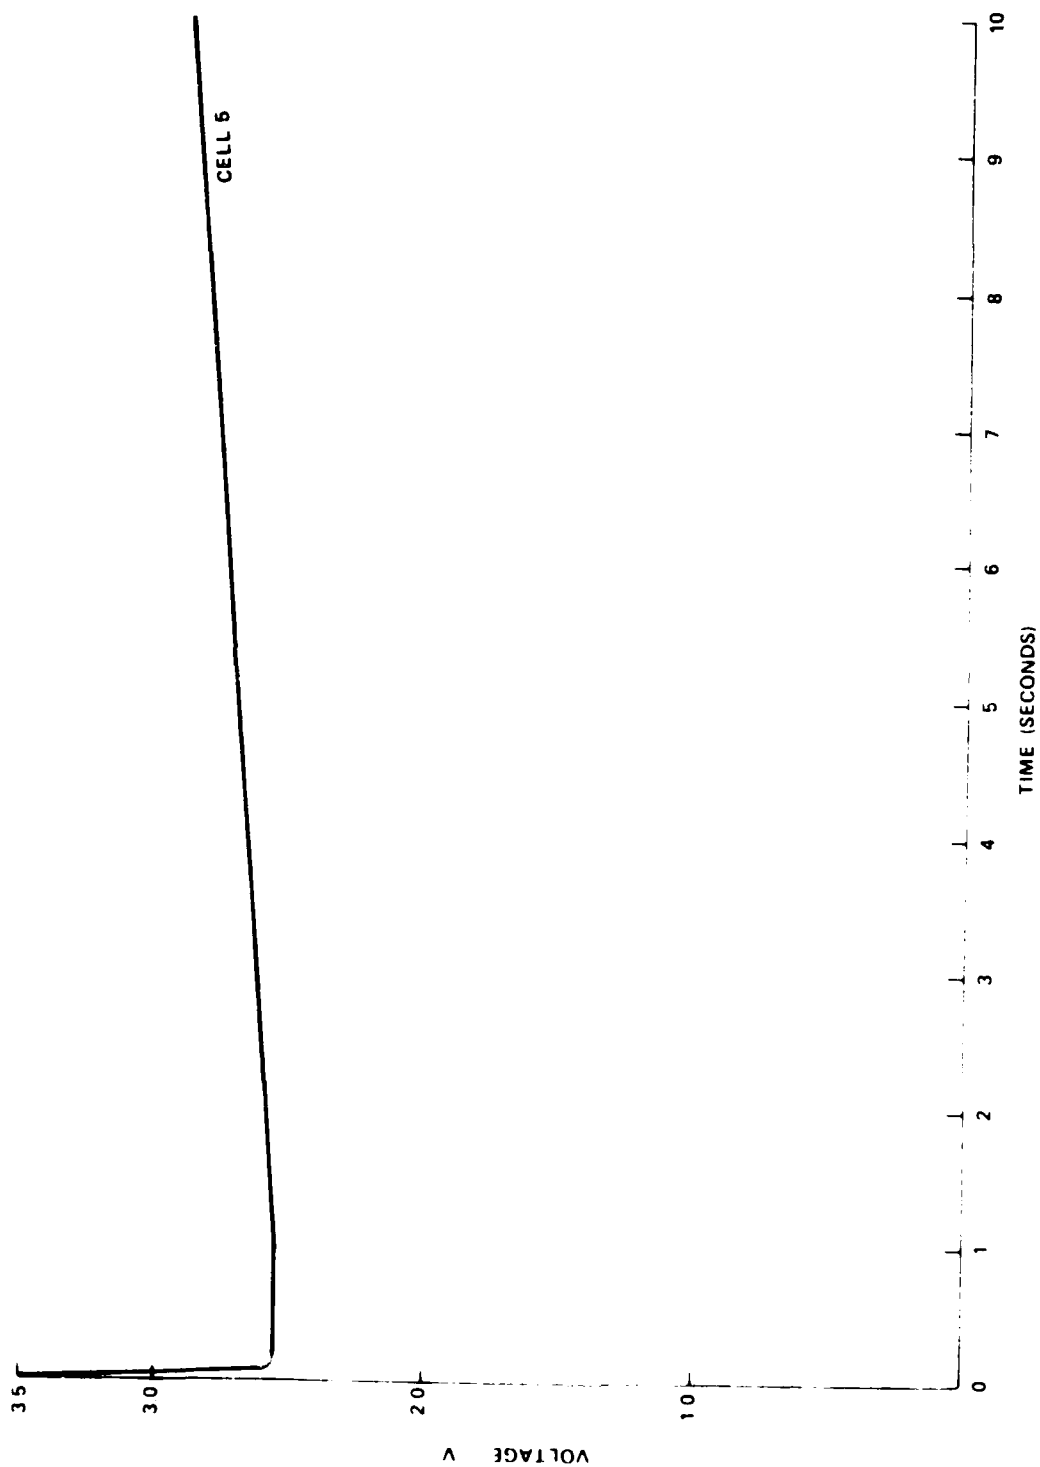
Figure 15. Voltage Delay after Storage for 3 Months at Room Temperature

Figure 16. Voltage Delay after Storage for 3 Months at Room Temperature

Figure 17. Voltage Delay after Storage for 3 Months at Room Temperature

The delay tests were carried out at a current of 300 mA using a high speed strip chart recorder. Of the five cells only one showed a slight delay. All cells retained their full capacity. The results are plotted in Figures 15, 16 and 17 and the capacity listed in Table 6.

It is obvious from this test that three months storage at room temperature has no ill effects on the voltage delay or the capacity of the cell. The delay is not much different from that of a fresh cell and the entire capacity seems to remain available for discharge. This has generally been the result of most of the tests run at room temperature, including the early tests covering one month storage.
